PASSAIC RIVER BASIN  
PEQUANNOCK RIVER TRIBUTARY,  
MORRIS COUNTY  
NEW JERSEY

# TERRACE LAKE DAM NJ 00542

## PHASE 1 INSPECTION REPORT NATIONAL DAM SAFETY PROGRAM.

TERRACE LAKE DAM (NJ00542)

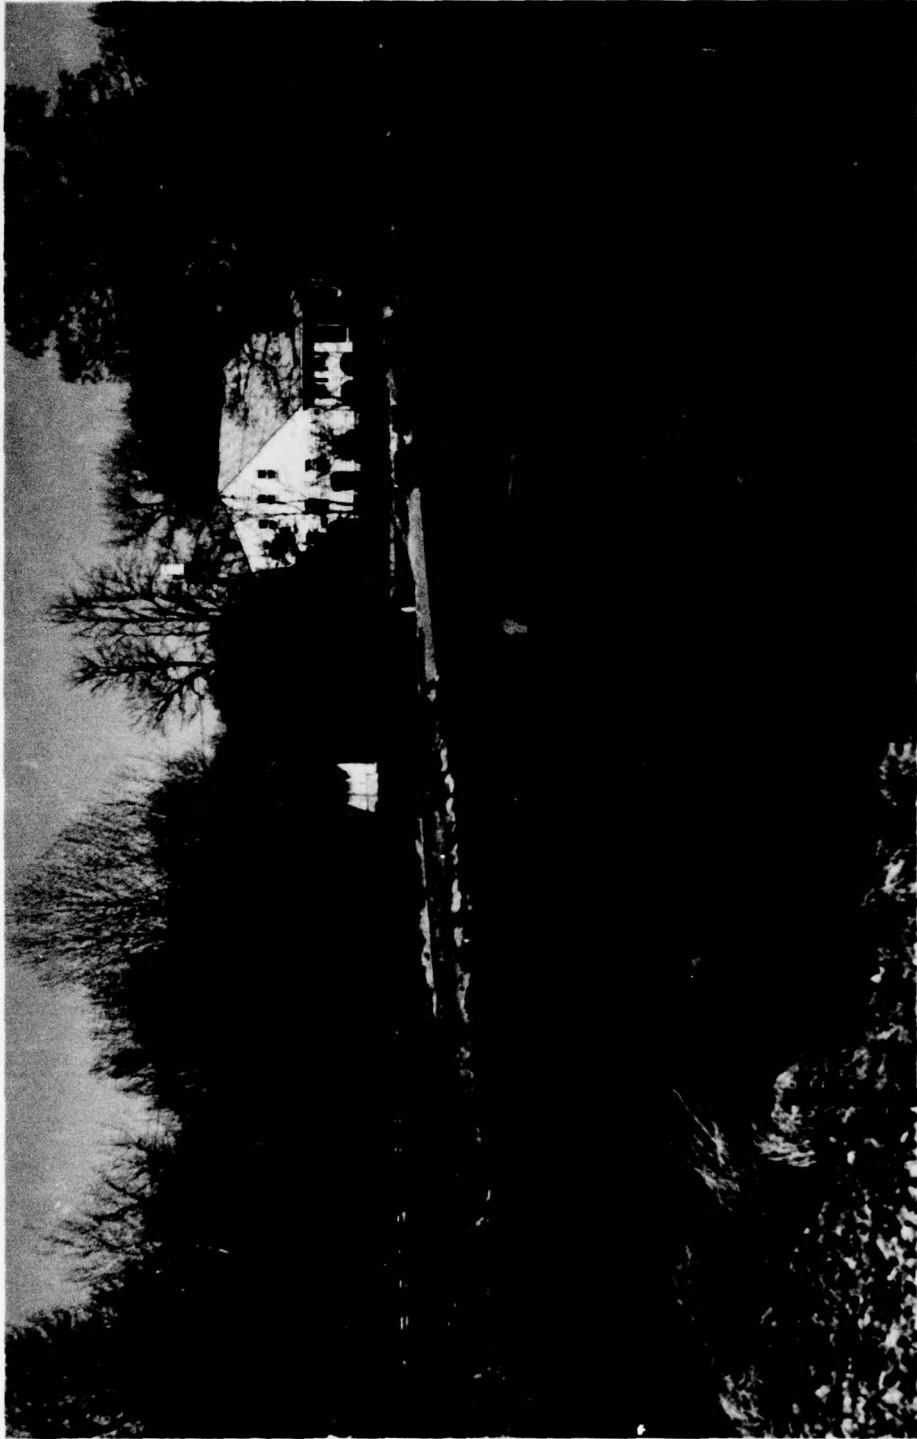
OVERVIEW - TERRACE LAKE DAM

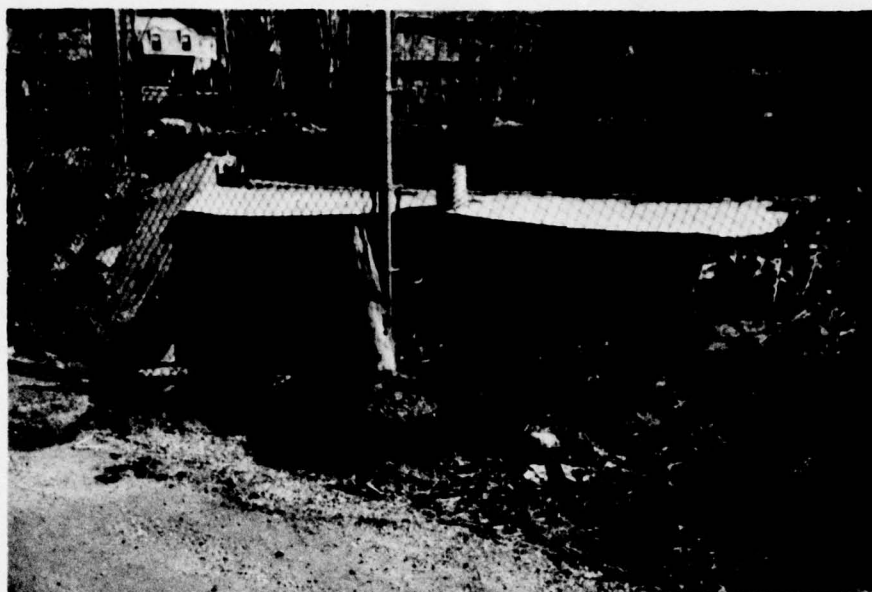
PHOTO 1  
SPILLWAY CREST

The spillway was observed to be in satisfactory condition. Overflow from the spillway flows onto an apron and then into a box culvert under Terrace Road. Entrance to the culvert was partly blocked by stones and debris. Near the mid-section of the road the culvert transitions to a 48-inch corrugated metal pipe. The 48-inch pipe discharges into a small pond before flowing into the downstream channel.

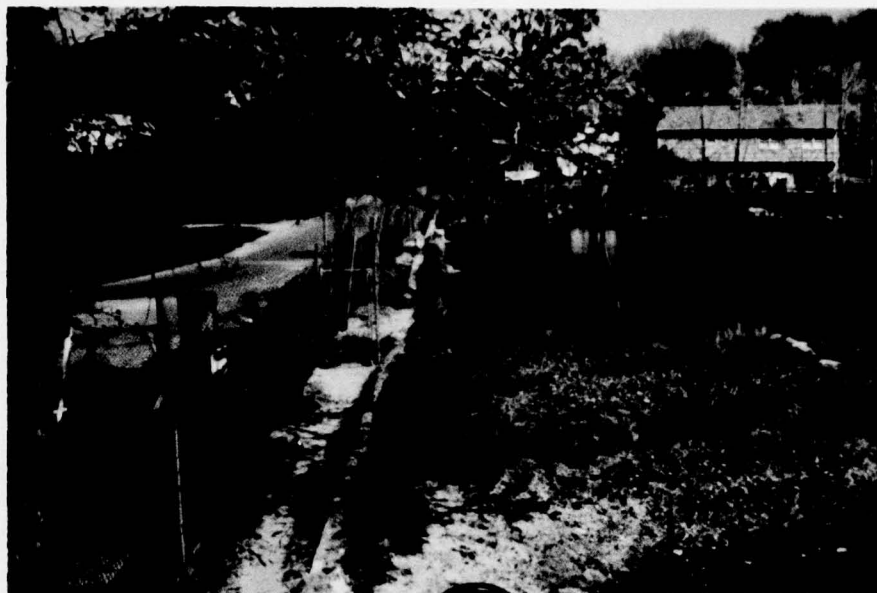
PHOTO 3

The east-west embankment at the main lake area was generally grass covered with some bare areas. The corewall is exposed for most of its length and appears to be structurally intact. The north-south embankment along the east side of lake is significantly deteriorated and eroded. The dam at the swim area consists of a concrete core wall, part of which is modified to form a sliding platform.

CREST OF DAM - NORTH EDGE OF LAKE

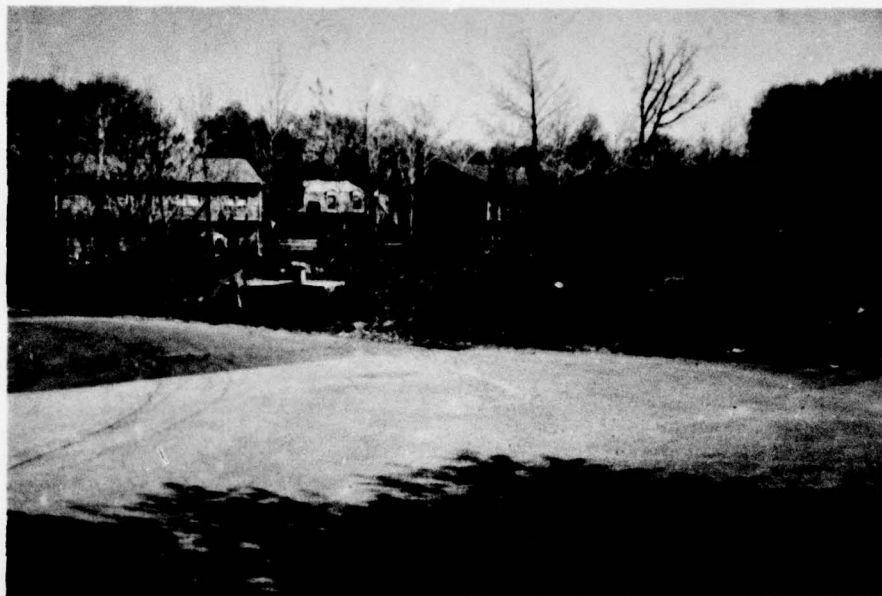
PHOTO 5

DOWNSTREAM FACE OF DAM - NORTH EDGE OF LAKE

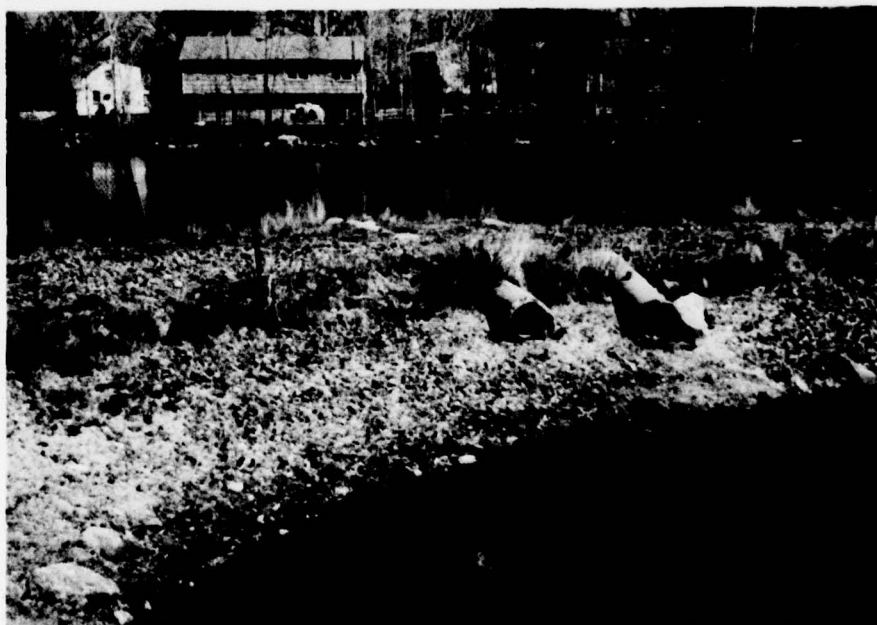
PHOTO 8

LEVELING PIPES IN DIKE BETWEEN  
SWIMMING AREA AND MAIN LAKE

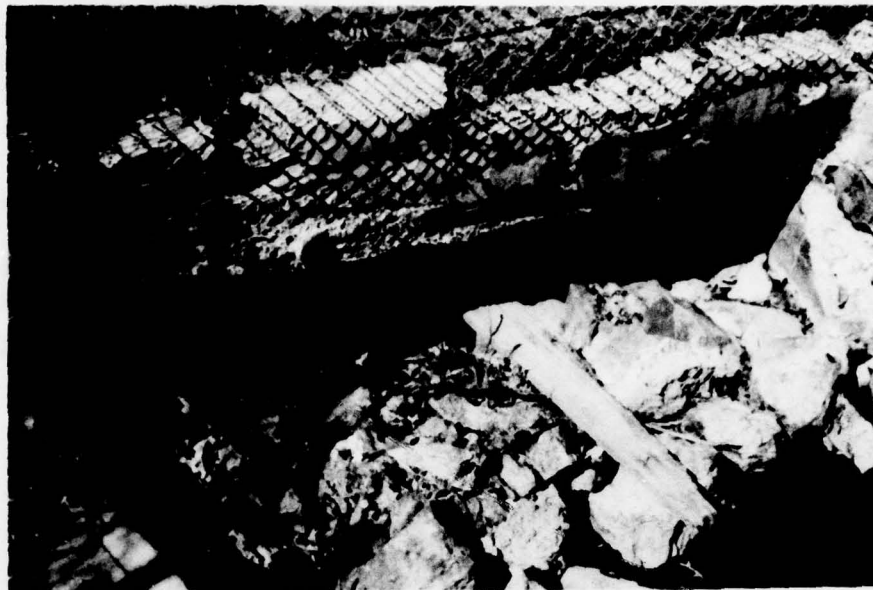
PHOTO 9

Reportedly, the box culvert under Terrace Road is undersized and often backs up causing flooding conditions in the vicinity of the road. Reportedly, the dam is occasionally overtopped due to heavy rain and on one occasion the house immediately downstream from the spillway was inundated to approximately one foot above ground level. The inundation apparently was primarily due to the inadequate capacity of the culvert.

VISUAL EXAMINATION OF	OBSERVATIONS	REMARKS OR RECOMMENDATIONS
CONDITION (OBSTRUCTIONS, DEBRIS, ETC.)	Rocks and debris at entrance to box culvert result in a significant obstruction to flow.	Discharge from spillway discharge cha enters box culvert under minor road directly downstream from dam.
SLOPES	From the box culvert, discharge is piped across a lawn to a small pond. The pond outlets into a small stream bed located between backyards of homes.	
STRUCTURES ALONG BANKS	3 homes are located adjacent to the small pond approx. 100' downstream from the dam.

CULVERT UNDER ROAD DOWNSTREAM FROM SPILLWAY

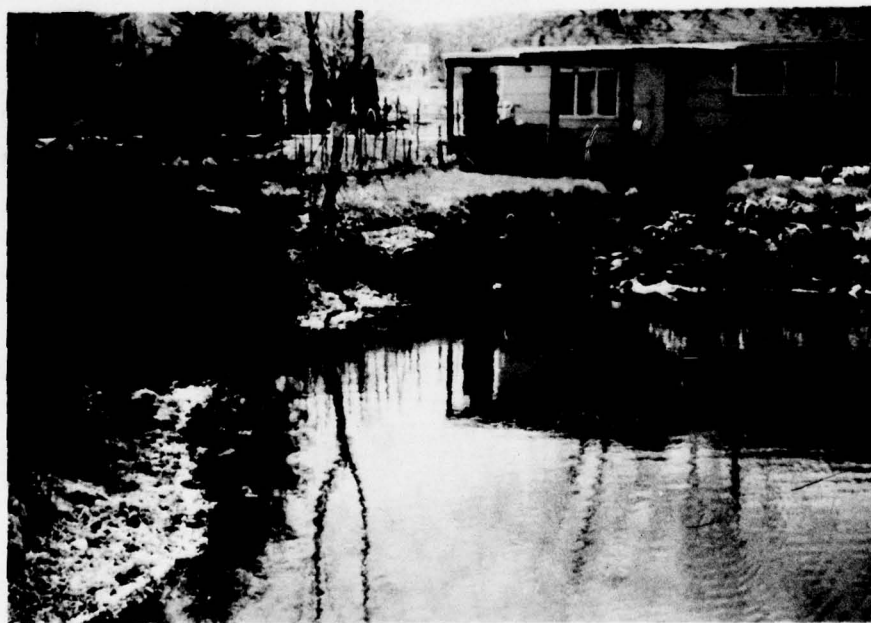
PHOTO 10

OUTLET OF CULVERT DOWNSTREAM FROM SPILLWAY
